## IPP, Unit 2 LSB Erosion (270T151)

In April, MD&A inspected the last stage buckets of Intermountain #2 in the hoods to provide Intermountain Power with a second opinion concerning the need to replace the buckets during a planned outage in 2010. Intermountain #2 is a GE S2 turbine with 30" last stage buckets and steam conditions of 2400#/1000°F/1000°F that went into service in 1987. The turbine was originally rated at 820 MW but you reported that the HP sections of both Intermountain units have been replaced with Alstom upgrades so the output is now higher.

**RECOMMENDATIONS/CONCLUSIONS**

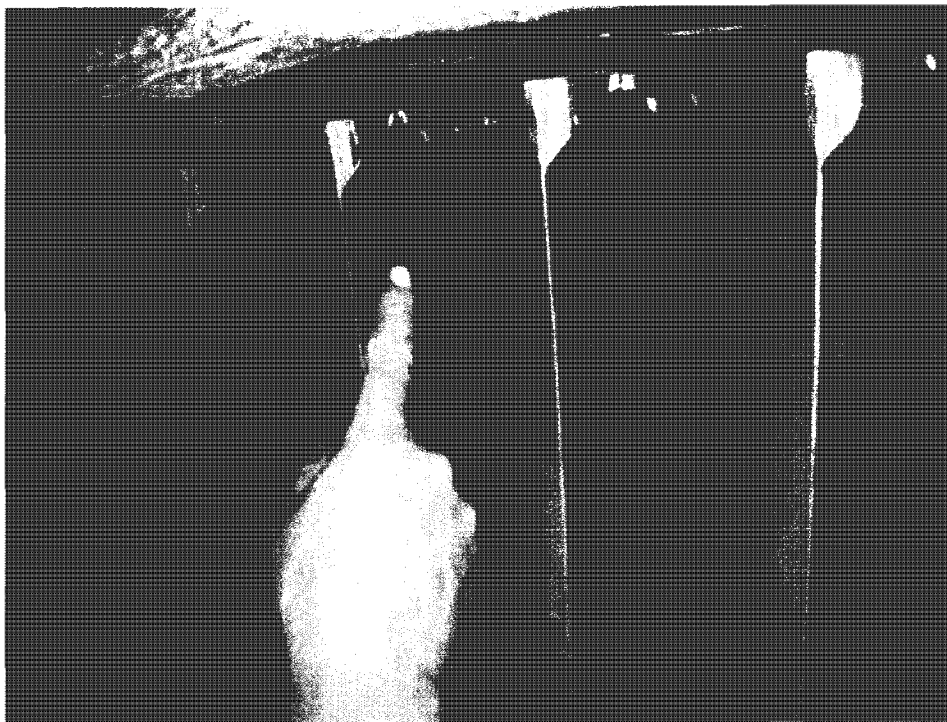
LP C TE L-0 1

The L-0's on LP A, B, and C were visual and NDE examined per TIL-1521 and GEK46354. As noted in past IPP QC records there is erosion on Inlet Side of all L-0 Buckets.

PRO comments are profile doesn't cause to much short term concern but should be replaced at next major outage.

Monitor LP L-0's per TIL-1521 and GEK46354 and replace on next major outage.

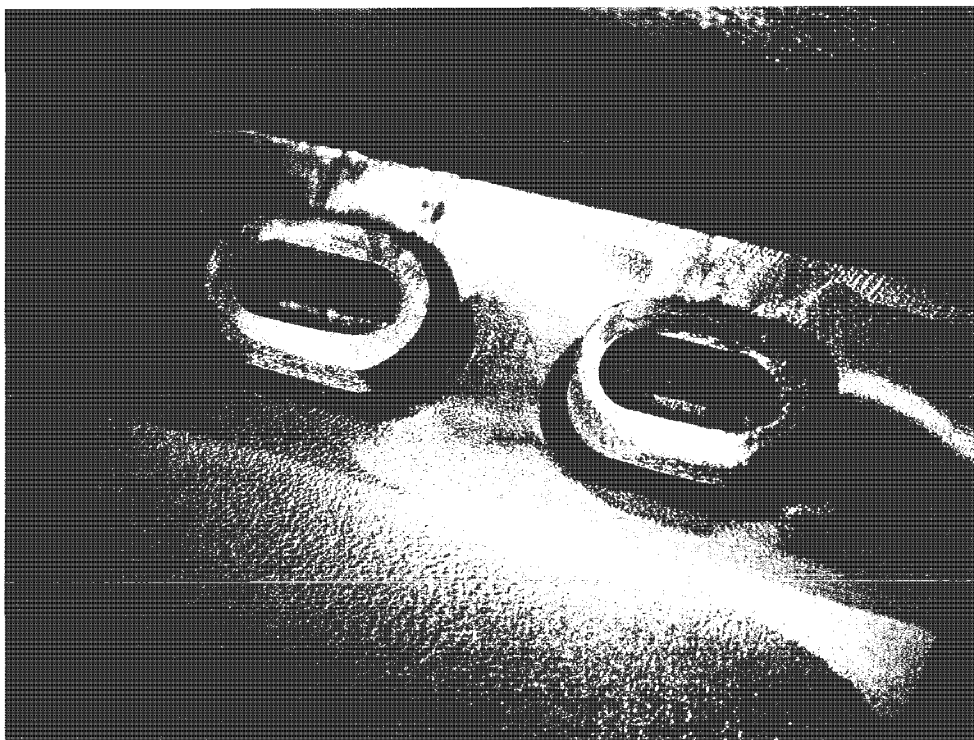
Figure 4-TA Last Stage Swelled Tenons

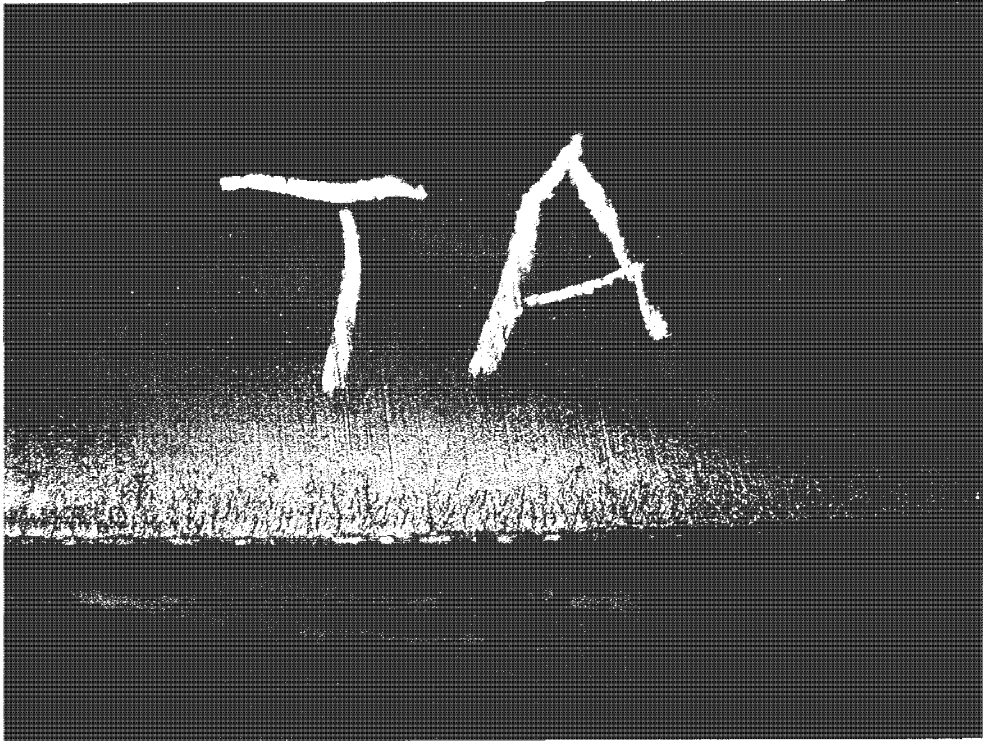
Figure 5-TA Last Stage Bucket with Erosion on Discharge Edge

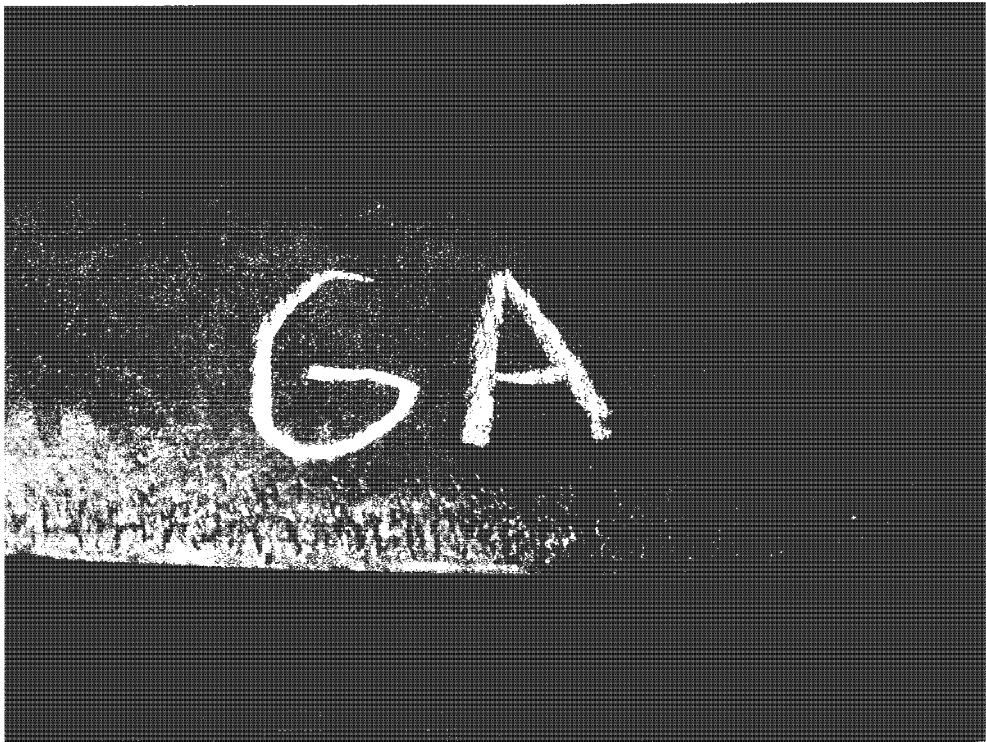
Figure 9-GA Last Stage Bucket with Erosion on Discharge Edge

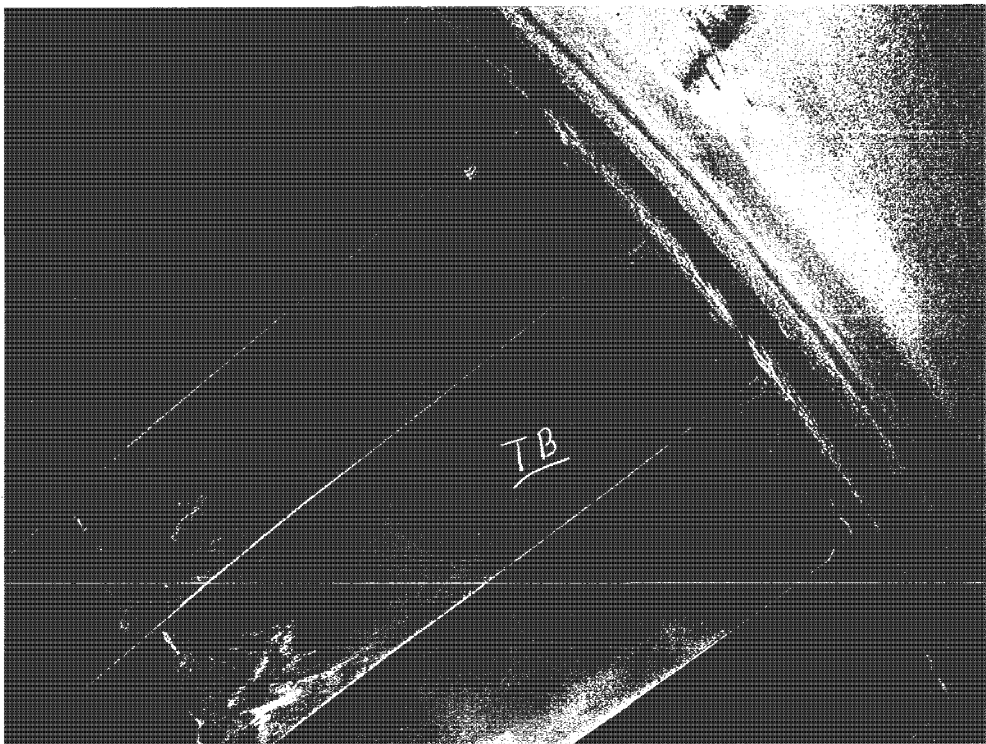
Figure 10-TB Last Stage Buckets

TB	<ul style="list-style-type: none"> <li>-Trailing edge erosion approximately the same as GB or slightly worse, but there are no erosion grooves that result in notches in the trailing edge.</li> <li>-Swelled tenons as bad or slightly worse than GB.</li> <li>-Swelled tenon sides about <math>3/32</math>" thick at top. Eroded to .035" thick on leading side on inside (2/3 gone).</li> <li>-Leading edge erosion similar to TC, with erosion on convex side back <math>1/8</math>"-<math>3/16</math>" from leading edge. Heavier erosion down 3"-4" from tip.</li> </ul>
GB	<ul style="list-style-type: none"> <li>-Trailing edge erosion worse than "C", but still no erosion grooves extend to trailing edge.</li> <li>-Discharge side tenons have erosion similar to "C" on the top which is worse on the trailing tenon. There is also up to <math>1/16</math>" of erosion on the base of the tenons with the most on the front tenon on the inside.</li> <li>-Leading side of cover eroded moderately and similar to "C".</li> <li>-Leading edge of vane appears to have less erosion than TC and about the same as GC, without the step seen on TC. Heaviest erosion only goes down a few inches.</li> </ul>

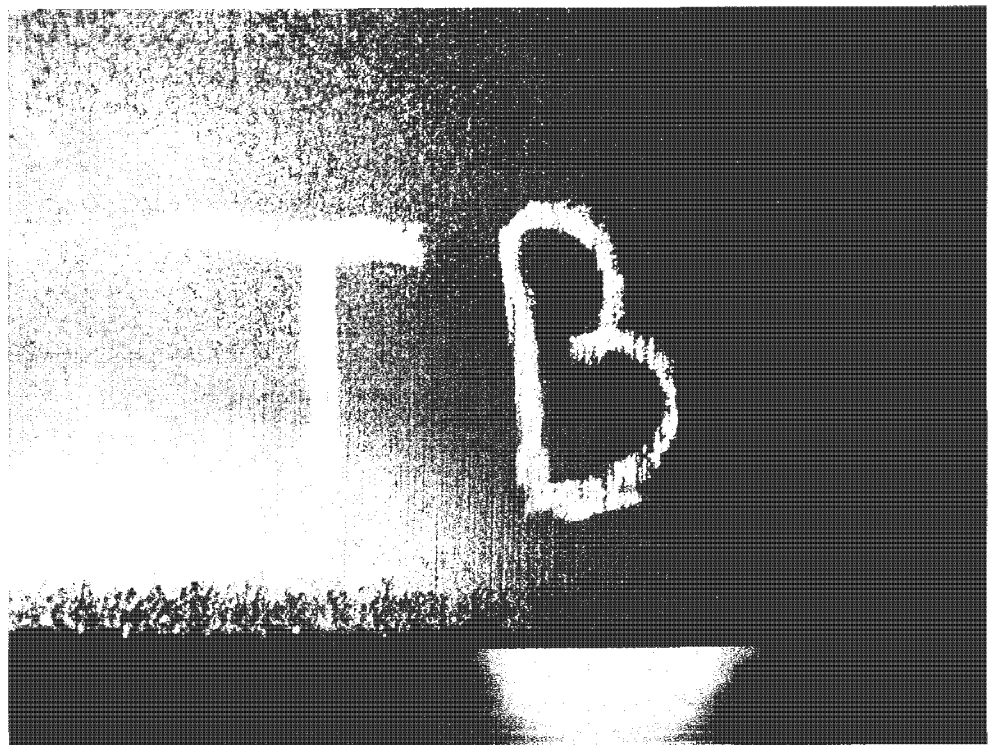
Figure 13-TB Last Stage Bucket with Erosion on Discharge Edge

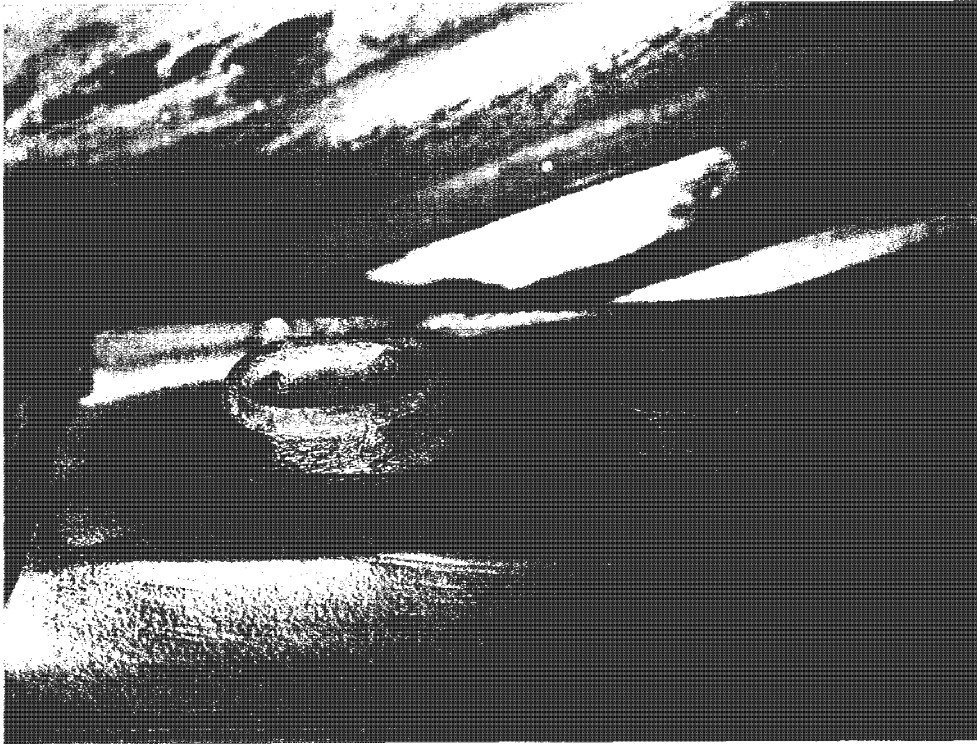
Figure 17-GB Last Stage Bucket with Erosion on Swelled Tenons

3. The last stage covers should be replaced if the buckets are not replaced.
  - The erosion of up to nearly 2/3 of the thickness of the discharge side tenons is severe enough to require replacement. Please note that special attention should be given to the swelling of the discharge tenons because incorrect swelling of the discharge tenons is considered the likely cause of two of the 30" L-0 failures. It appeared that extending the swelling too far toward the bucket restricted the ability of the bucket to untwist during service and increased the stress at the base of the trapezoidal section at the tip of the vane. The increased stress plus erosion notches in the leading edges combined to initiate cracks which resulted in tip failures on the unshielded 30" buckets. This special attention to the swelling process should also be applied to a new bucket installation if the new buckets have the same side entry cover design as the current last stage buckets.

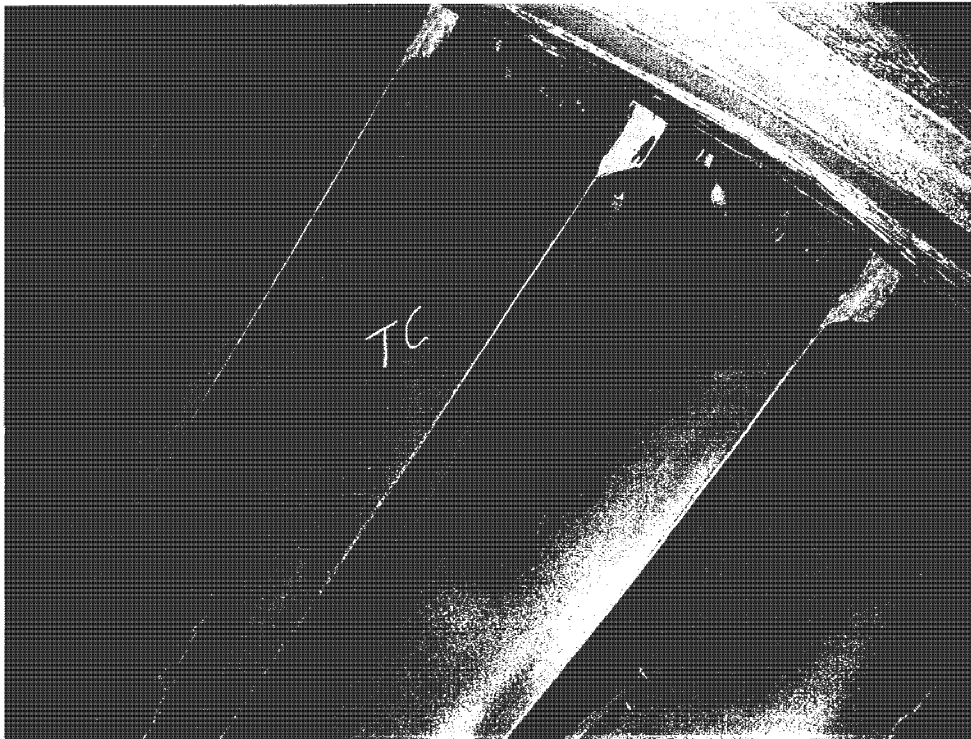
Figure 19-TC Last Stage Buckets

TC	<ul style="list-style-type: none"> <li>-Trailing edge has more erosion than GC, with the buckets that are apparently more downstream having some erosion grooves on convex side inside tie wire, but no notches in trailing edge.</li> <li>-Discharge side tenons and admission side of cover similar to 20GC.</li> <li>-Admission edges of vanes have more erosion than 20GC, with erosion back <math>1/16</math>"-<math>3/16</math>" from leading edge but no significant notches in leading edge. Heavier erosion down 3"-4".</li> </ul>
GC	<ul style="list-style-type: none"> <li>-Virtually no erosion on trailing edge.</li> <li>-Some erosion on discharge side tenons, with erosion completely through on a few trailing tenons.</li> <li>-Moderate erosion on leading edges of covers.</li> <li>-Moderate erosion on leading edges of vanes near the tip down 2"-3" from the bottom of the trapezoid.</li> </ul>

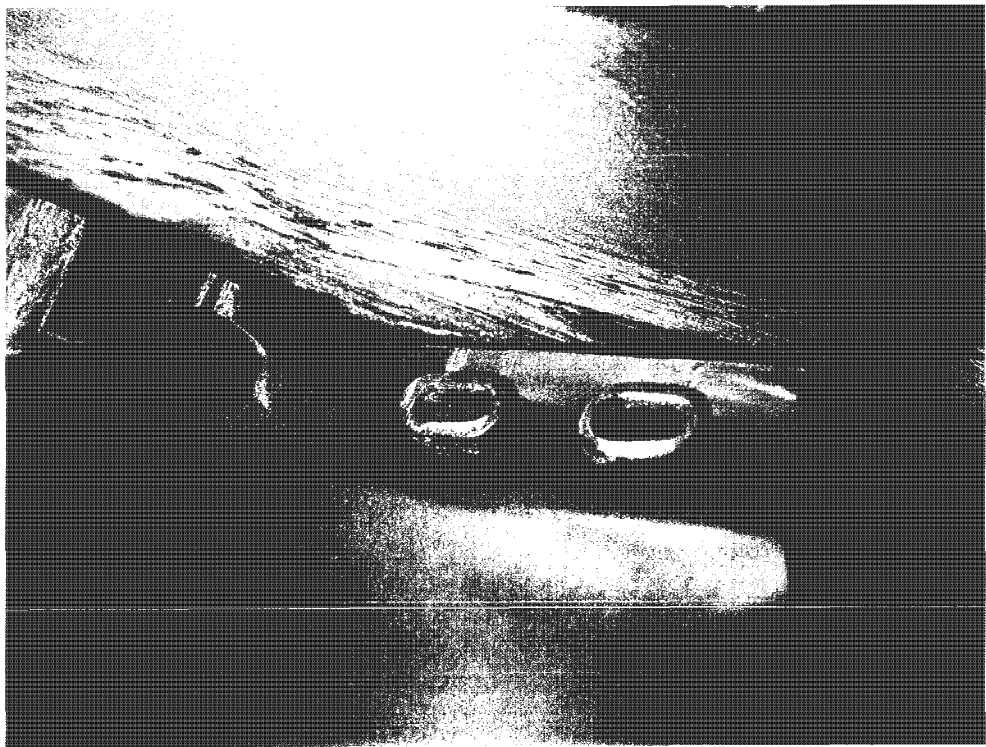
Figure 22-TC Last Stage Swelled Tenons

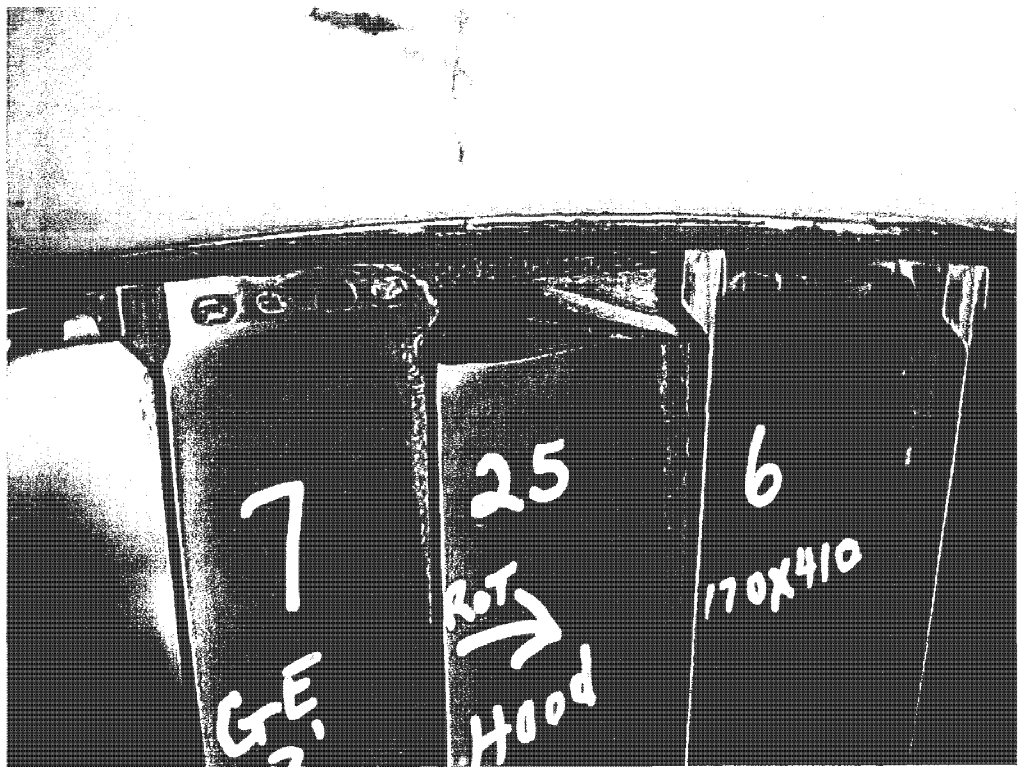
Figure 27-Unshielded 30" Last Stage Bucket with the Tip Missing-Station A

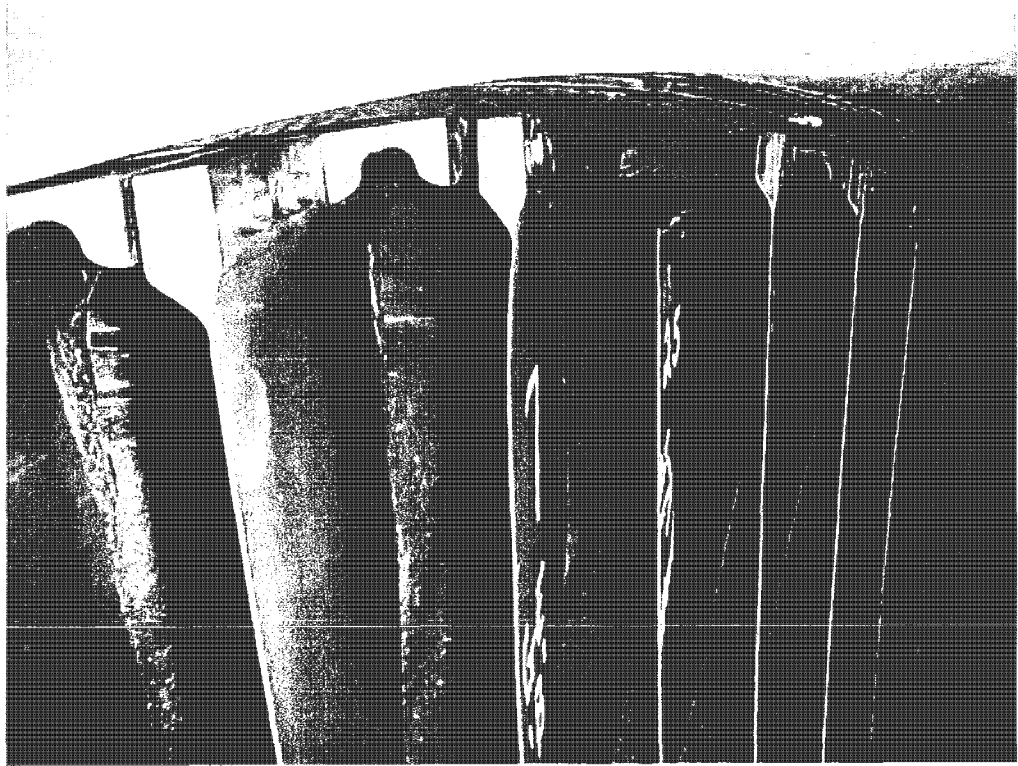
Figure 28-Unshielded 30" Last Stage Bucket with the Tip Missing-Station A

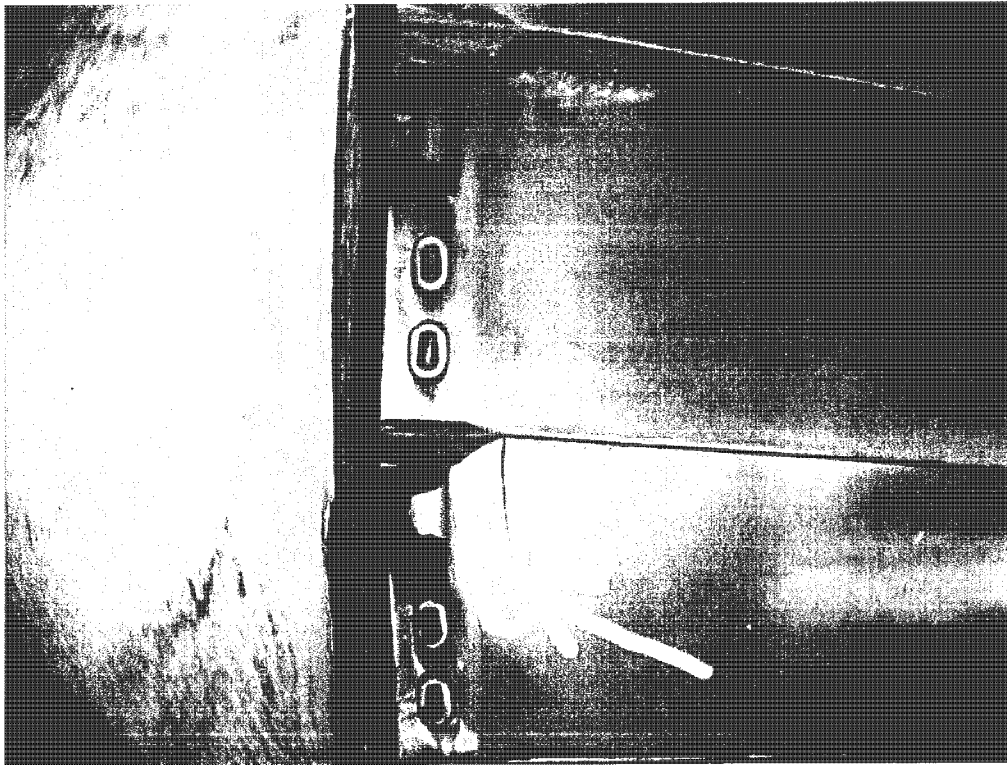
Figure 29-Unshielded 30" Last Stage Bucket with Crack-Station A
